CREATING A "CULTURE OF SAFETY" THE 2008 IADC SAFETY AWARD

2008 AWARD WINNING PROJECT

The Dredging Works

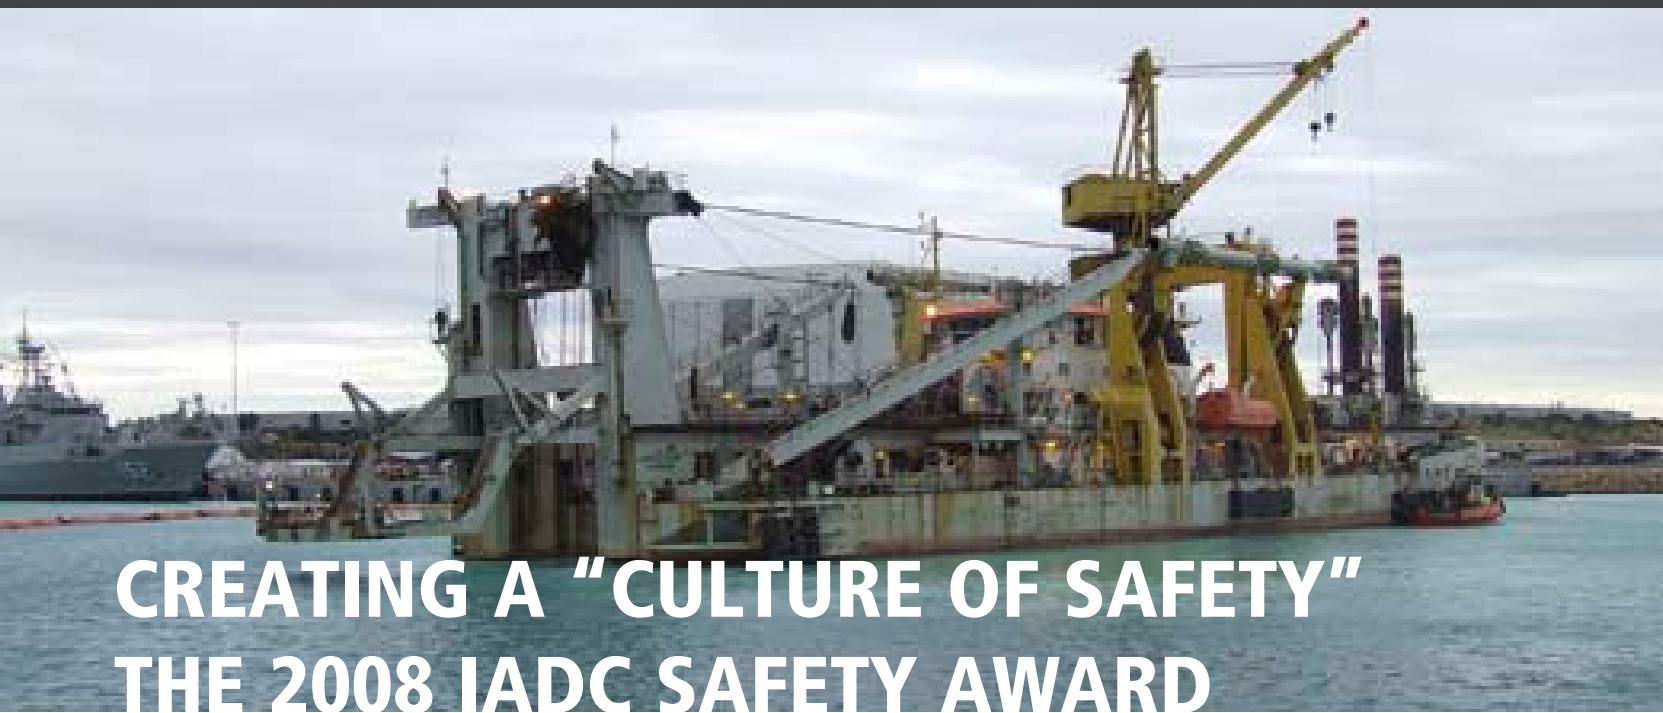
Above: The cutter suction dredger *Leonardo da Vinci* at work at the Australian Marine Complex. Work for a floating dock was completed with zero non-compliances and no lost-time injuries.

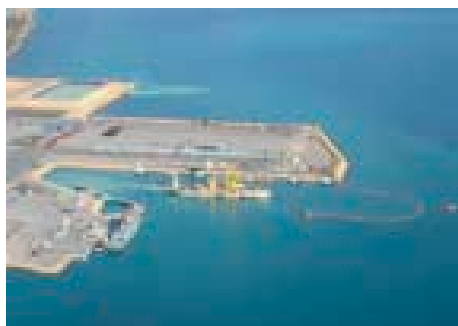
Figure 1. An aerial overview of the Australian Marine Complex site in Jervoise Bay, Western Australia.

Last year Flanders Dredging Corporation N.V. (FDC), a 100 percent subsidiary of Jan De Nul Group, completed a project at the Australian Marine Complex (AMC) located in Jervoise Bay, Western Australia (Figure 1). The project was highly commended for outstanding achievements by the client's project manager, both on Occupational Safety and Health as well as Environmental Management.

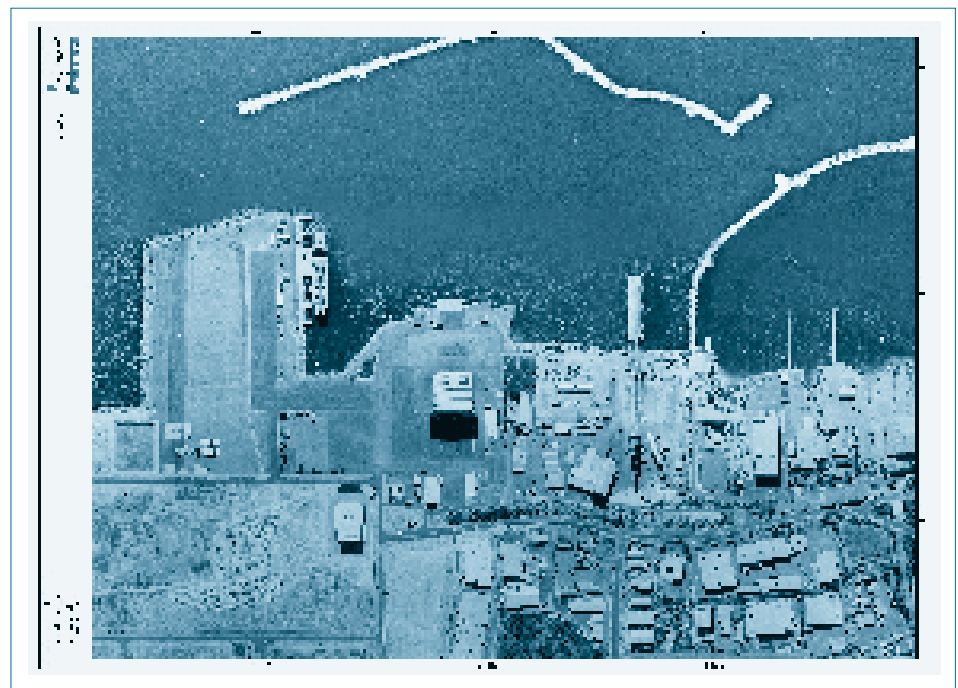
Figure 3. Aerial picture of whole AMC site with at the left the location for the future ship lift.

The dredging works for a floating dock took place at the AMC Common User Facility (CUF) in Fremantle, Australia (Figures 2 and 3). The works comprised dredging a pocket of 65 m x 250 m to -17.7 m CD to accommodate a floating dock at the AMC ship repair facilities. The works were performed by the cutter suction dredger (CSD) *Leonardo da Vinci* which excavated about 100,000 m³. All dredged materials had to be placed in onshore containment areas.

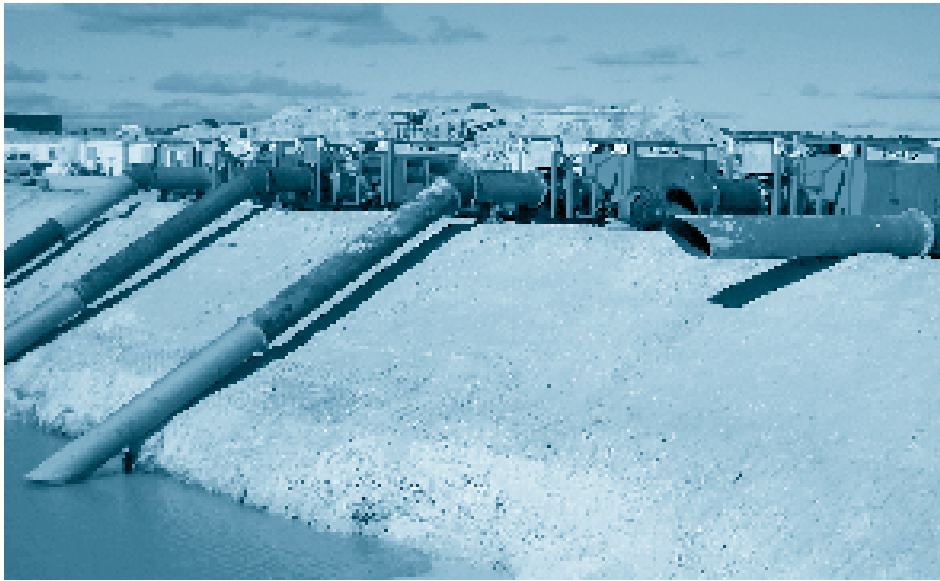
Figure 4. Four Van Heck pumps were used to pump the tail water from the reclamation area into the settlement pond.

The tail water of the reclamation was discharged into the southern part of the Cockburn Sound Harbour after being decanted in a settlement pond. To pump the tail water from the reclamation area to the settlement pond, four Van Heck pumps were installed (Figures 4 and 5).

Dredged material was composed of calcareous material and pumped ashore into a reclamation area 300 m x 200 m. Process water running off the reclamation was pumped by four pumps into a small settlement area 80 m x 200 m and continuously discharged through a weir box in the Cockburn Sound Harbour. Monitoring of water parameters, such as the turbidity created by the dredging action and from return water leaving the settling basin took place during the works at an agreed distance to ensure that the impact on the environment was minimised.

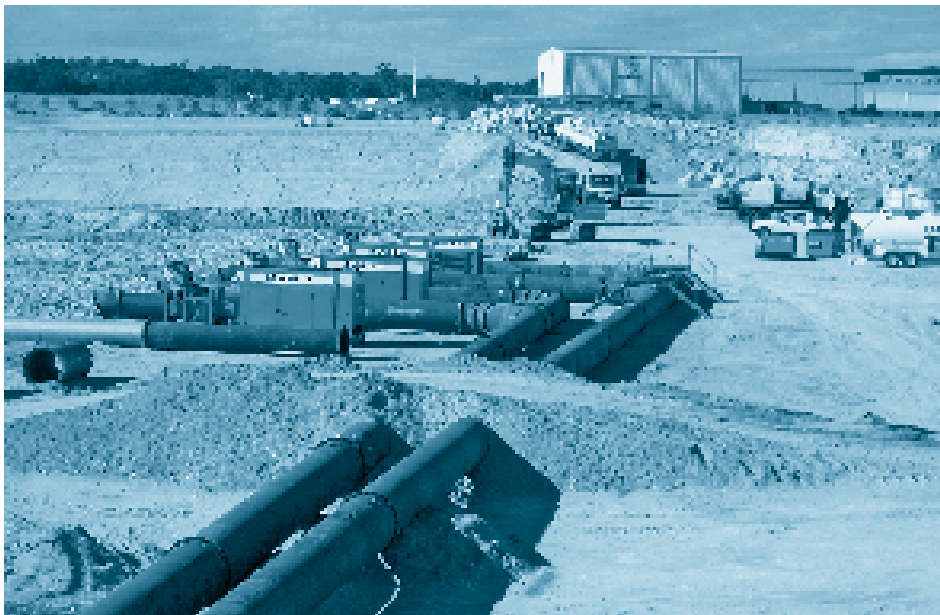
Figure 5. Another view of the Van Heck pumps from the reclamation area.

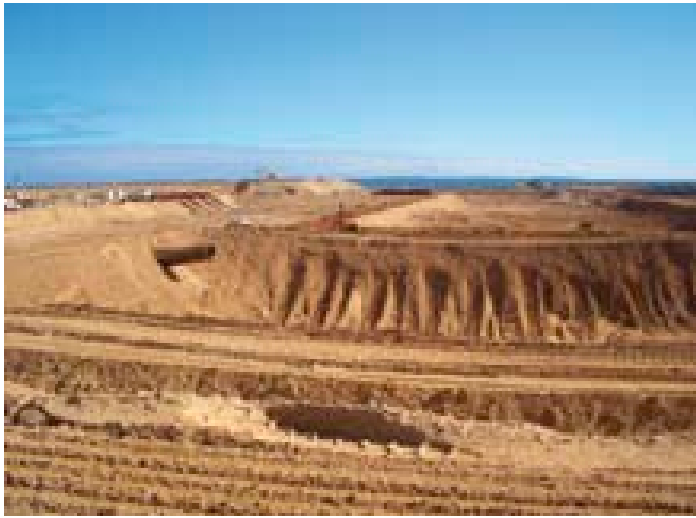
Figure 6. Preparations of the reclamation area and the initial settlement pond.

tract requirements for safety management. The success of the Environmental Management system was largely a result of the design and set up of the reclamation area and settlement ponds (Figures 6, 7 and 8). Contractually the Contractor was responsible for preparing the Dredge Management Plan and to seek approval of

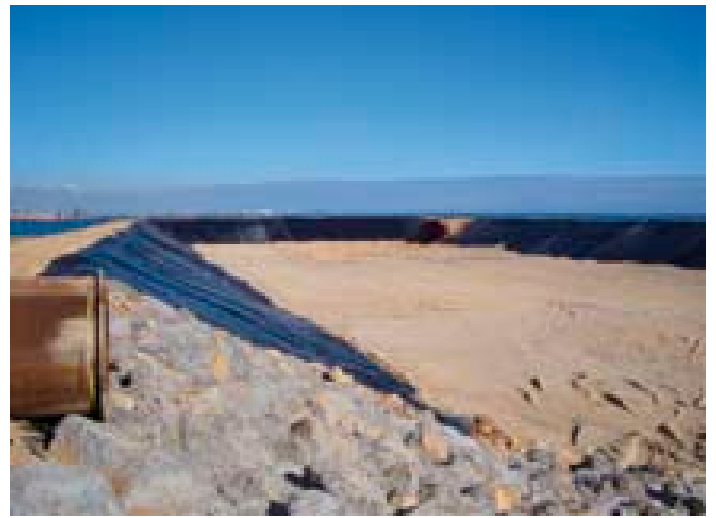
Figure 7. View of the main settlement pond.

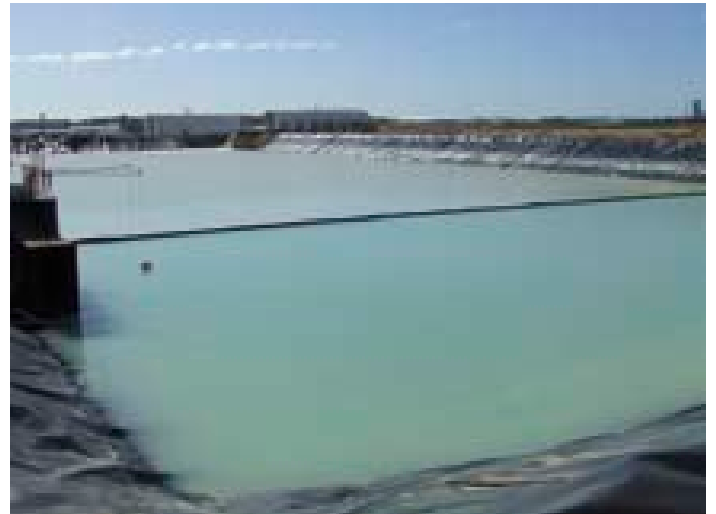
Figure 8. The settlement pond showing water quality monitoring and equipment (left) and silt screen in the middle.

The turbidity sensors (type Hydrolab DS 5X) gave readings in NTU (Nephelometric Turbidity Unit). An automated, solar

powered, real-time monitoring system with radio telemetry to a base station was installed at the weir boxes for long-term deployment. Data was sent to the office, where it was processed and analysed by specialised software, so that anomalies could be detected instantly.

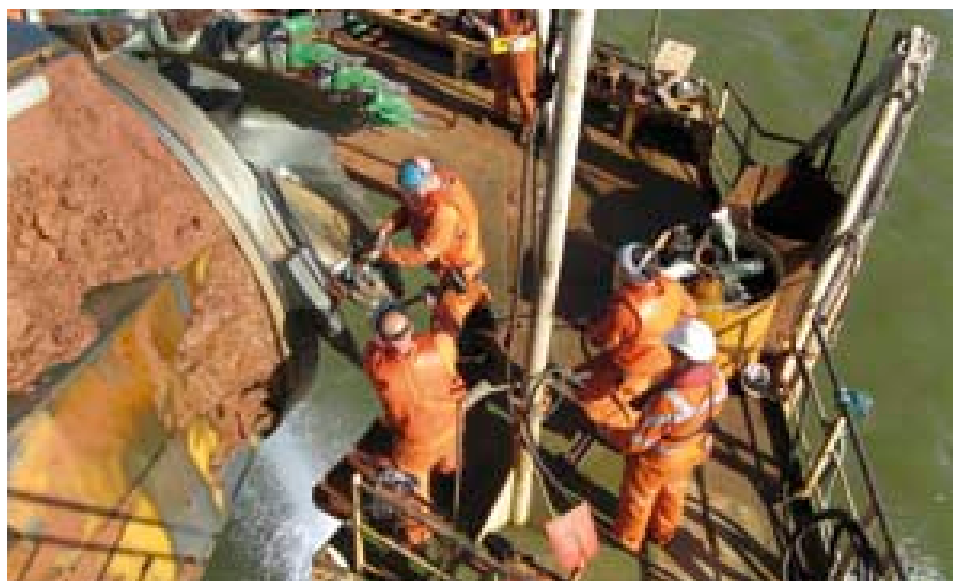
Figure 9. Crew members with Personal Protective Equipment (PPE), an essential element in ensuring proper occupational and safety standards.

Personal Protective Equipment (PPE) (Figure 9) is an important part of worker safety and can include face shields, safety glasses, hard hats, and safety shoes. In addition to the PPE that had previously been purchased to protect employees from serious workplace injuries or illnesses or other workplace hazards, further PPE was purchased including high-visibility vests, high-visibility fleeces, and raincoats and trousers.

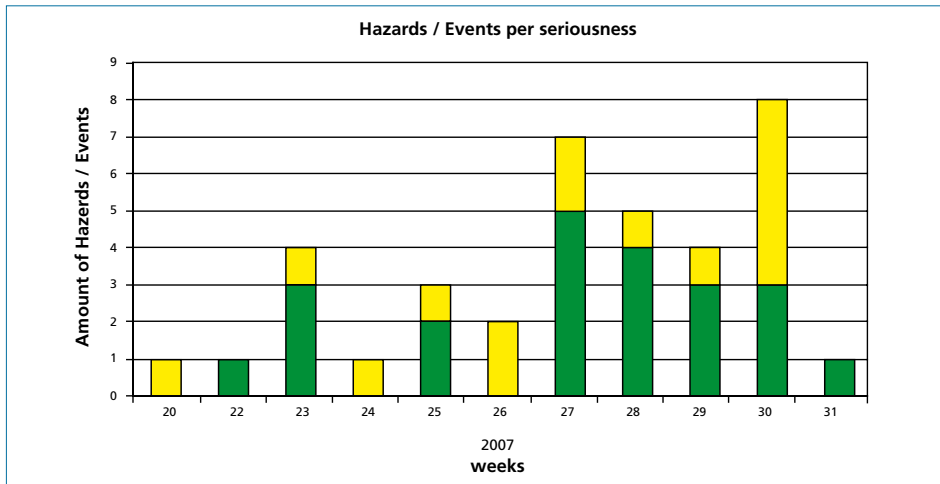
Figure 10. Hazards / Events per seriousness: Yellow indicates medium significant events. Green indicates events of low significance.

Of course, inevitably, some events were encountered in the course of the operations. In total, 37 “hazard observations” (known as events) occurred. Of these, 15 were “yellow” events and 22 “green” events, in which, according to FDC’s risk and impact matrix, yellow is classified as of medium significance and green as of low significance. None of the events were classified as high significance (red). All these events were investigated and addressed in a timely fashion (Figure 10).

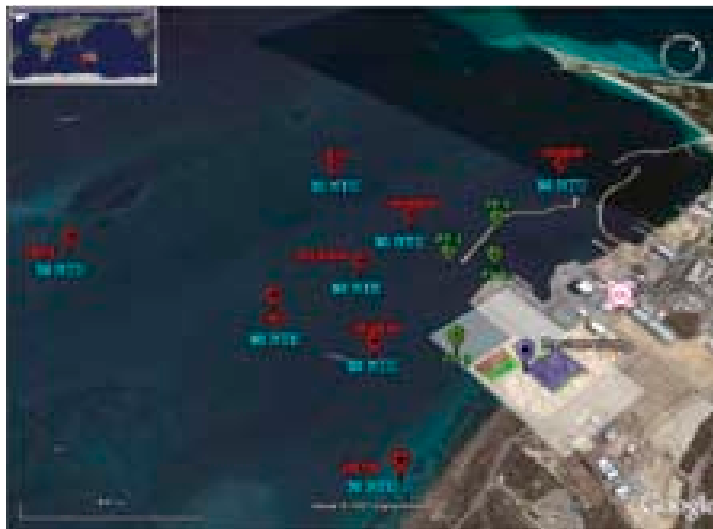
Figure 11. To protect the indigenous sea grass, turbidity monitoring took place at 12 strategic points.

Sea grass health was determined via measurements of shoot and leaf density by an independent environmental consultant. Twelve strategic points were chosen to monitor the turbidity (NTU), totals suspended solids (TSS) and light penetration depths (Secchi disk) and these were used to provide information about the turbidity during the dredging works (Figure 11). No exceedances were recorded during the entire execution of the project.
