STANY PENZAERT, HENDRIK NOLLET, ELKE ROMBAUT AND XAVIER LEPÈRE

ENVIRONMENTAL DREDGING OF A CHROMIUM CONTAMINATED FJORD

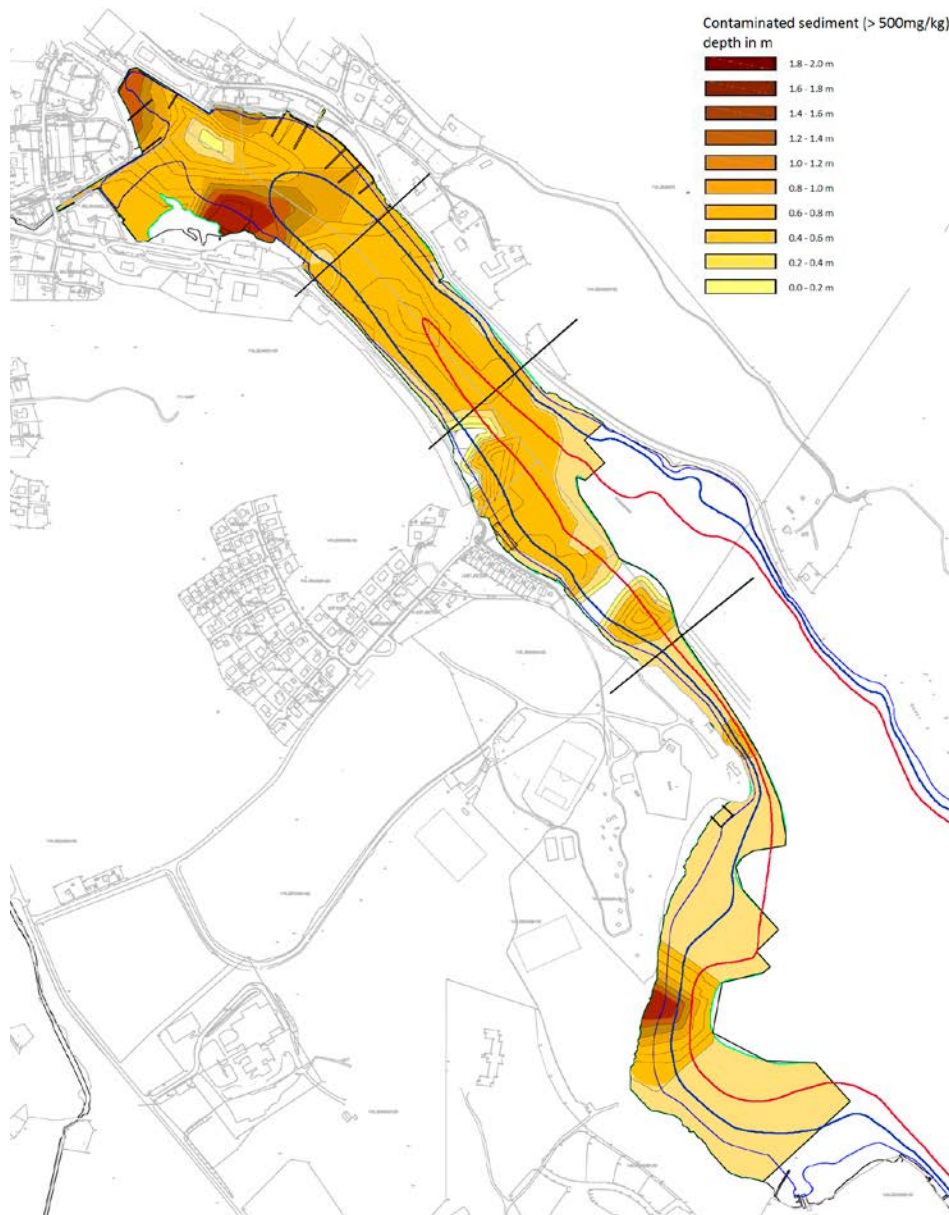
Figure 2. Overview of the dredged area with the various sediment depths.

200,000m³ to be dredged over a surface of about 350,000m². This implied the dredging of rather thin layers of sediment (Figure 2). The depth of dredging, however, went up to 14m.

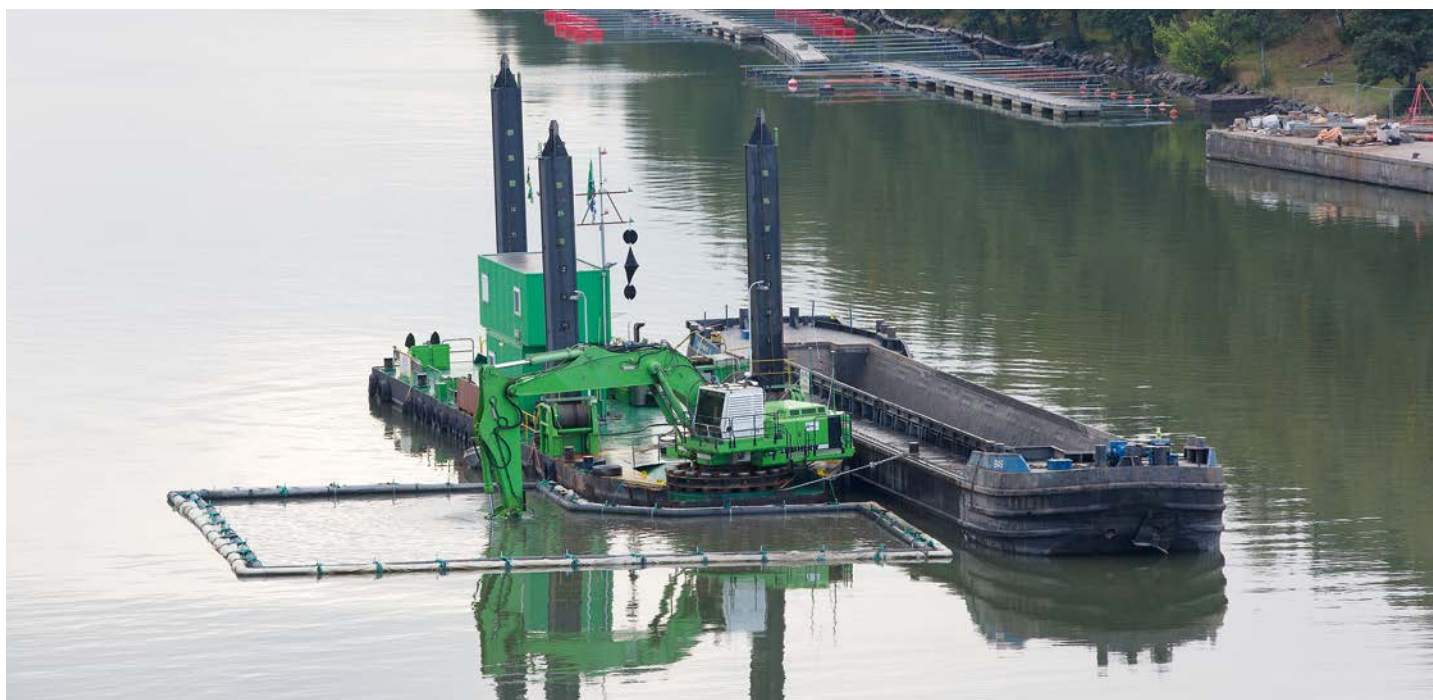
Figure 3. The dredger, *Ijburg*, in combination with a level-cut clamshell bucket was utilised to perform the dredging works in the Valdemarsviken fjord.

An appraisal was done on several environmental dredging techniques with special attention to the site conditions, sediment characteristics, environmental dredging performance standards, equipment capabilities, operating methods and strategies. As a result, dredging by using a hydraulic excavator equipped with a level-cut clamshell bucket or a visor bucket was selected as it could provide the most optimal dredging production, debris management, and dredging accuracy for site-specific conditions. The equipment is shown in Figures 3 and 4. In order to obtain extreme accuracy in dredging,

In addition to the operational controls, a mobile silt screen was installed at the dredger around the reach area of the excavator (Figure 3). In addition, fixed silt screens were installed further downstream of the fjord. The maximum allowed increase in turbidity in the Valdemarksviken fjord immediately outside the area where turbidity causing works were in progress (50m from the dredge) was 9 Nephelometric Turbidity Units (NTU) in relation to a reference point upstream.

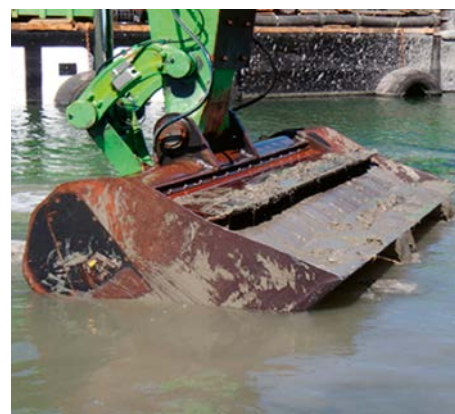
Figure 4. A visor bucket in being utilised for dredging at Valdemarsviken fjord.

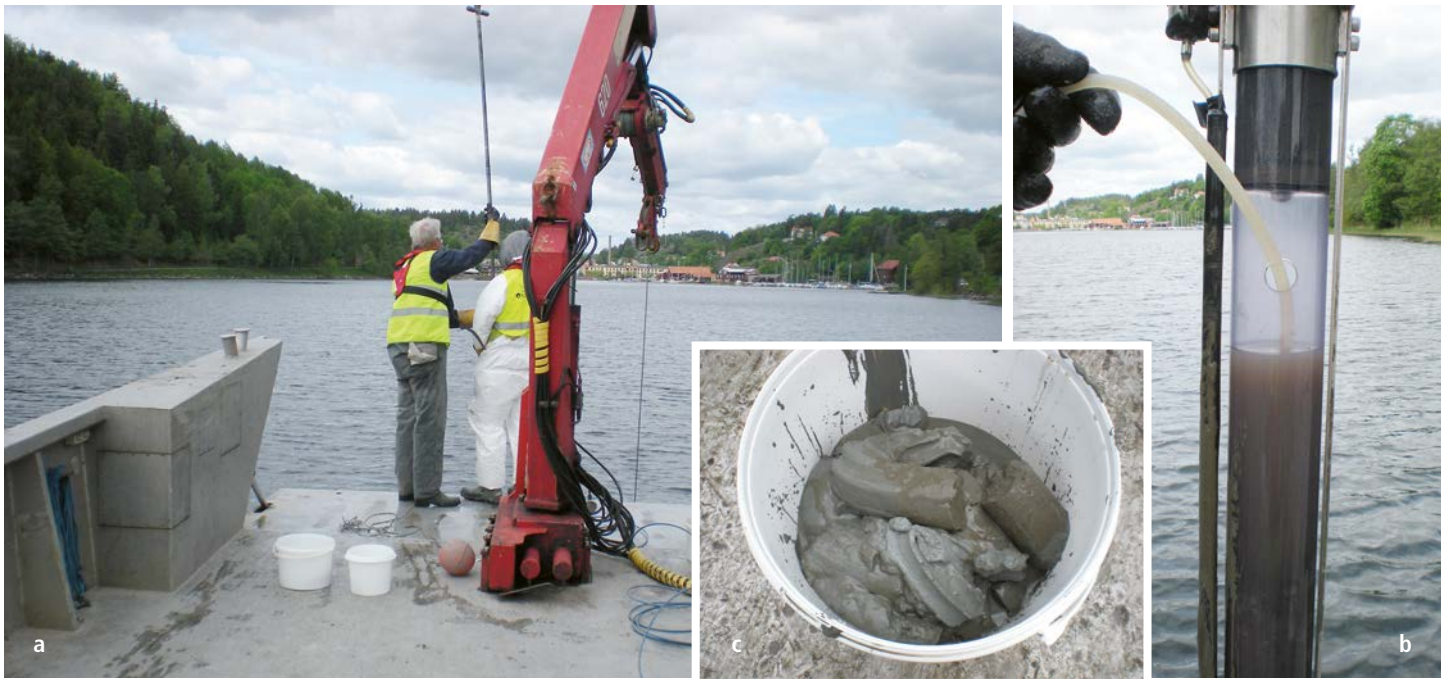
Figure 5. (a). Sediment sampling performed in the Valdemarsviken fjord (b). A manual core sampler collecting sediment sample. (c). A view of the collected sample.

The area to be dredged was extensively sampled from a small pontoon by using a manual core sampler, allowing undisturbed sampling at the desired depths. Disturbed and undisturbed samples were collected and the disturbed samples were used to perform the lab-scale stabilisation tests. The in-situ parameters of the sediments were determined on the undisturbed samples. Special attention was paid to pump off the water layer as shown in Figure 5 to ensure an "in-situ" quality of the sediments of the samples taken at the top of the sediments.

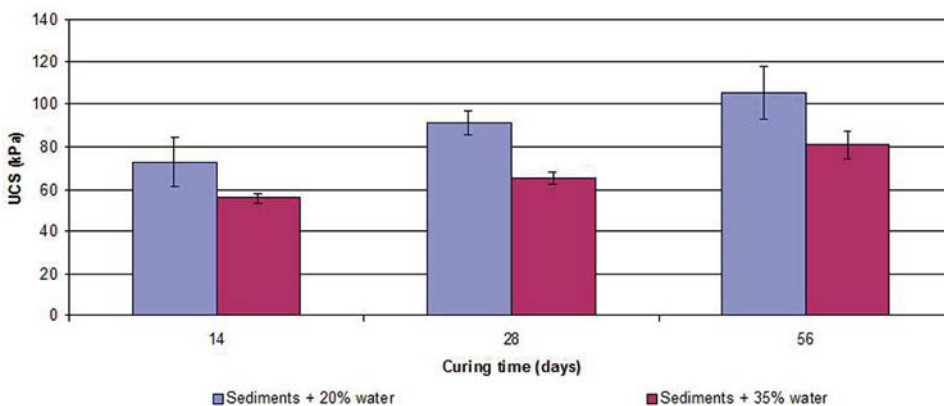
Figure 6. Results of sediment solidification

The different binders available in the Valdemarsvik area were tested with different concentrations and curing times. Through the tests, cement-based binders were found to give the best results in creating sufficient strength with a reasonable dosage. An overview of these results is given in Figure 6. It is important to note that the shear strength was tested indirectly by means of determining the Unconfined Compressive Strength (UCS) divided by a factor of two.

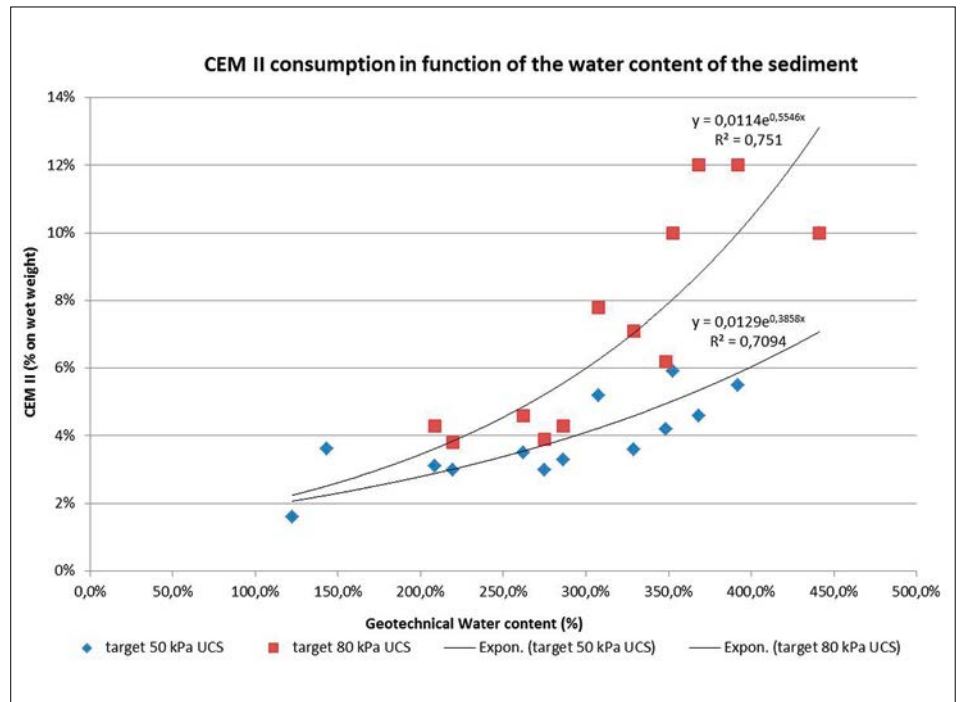
Figure 7. Relationship between water content and cement consumption to achieve 50 or 80 kPa UCS (= 25 or 40 kPa shear strength)

The binder dosage depends on the water content of the dredged sediments. This dosage differs during the whole dredging activity as a lot of parameters are involved in these variations such as dredged zone, differences in sediment granulometry, depth of the layer to dredge and slope of the bottom. With the lab trials, it was possible to establish a relationship between the water content of the sediments and the amount of binder needed to meet the criteria. This relationship is shown in Figure 7.

As the consumption of the binder during stabilisation of the sediments increased exponentially with increasing water content of the sediment, as illustrated in Figure 7, it was obviously important to select an appropriate dredging technique that avoids excessive addition of water. Mechanical dredging by means of a clamshell or a visor bucket was utilised. After, the sediments were transported by barges to the unloading quay. The decanted water on top of the sediments was

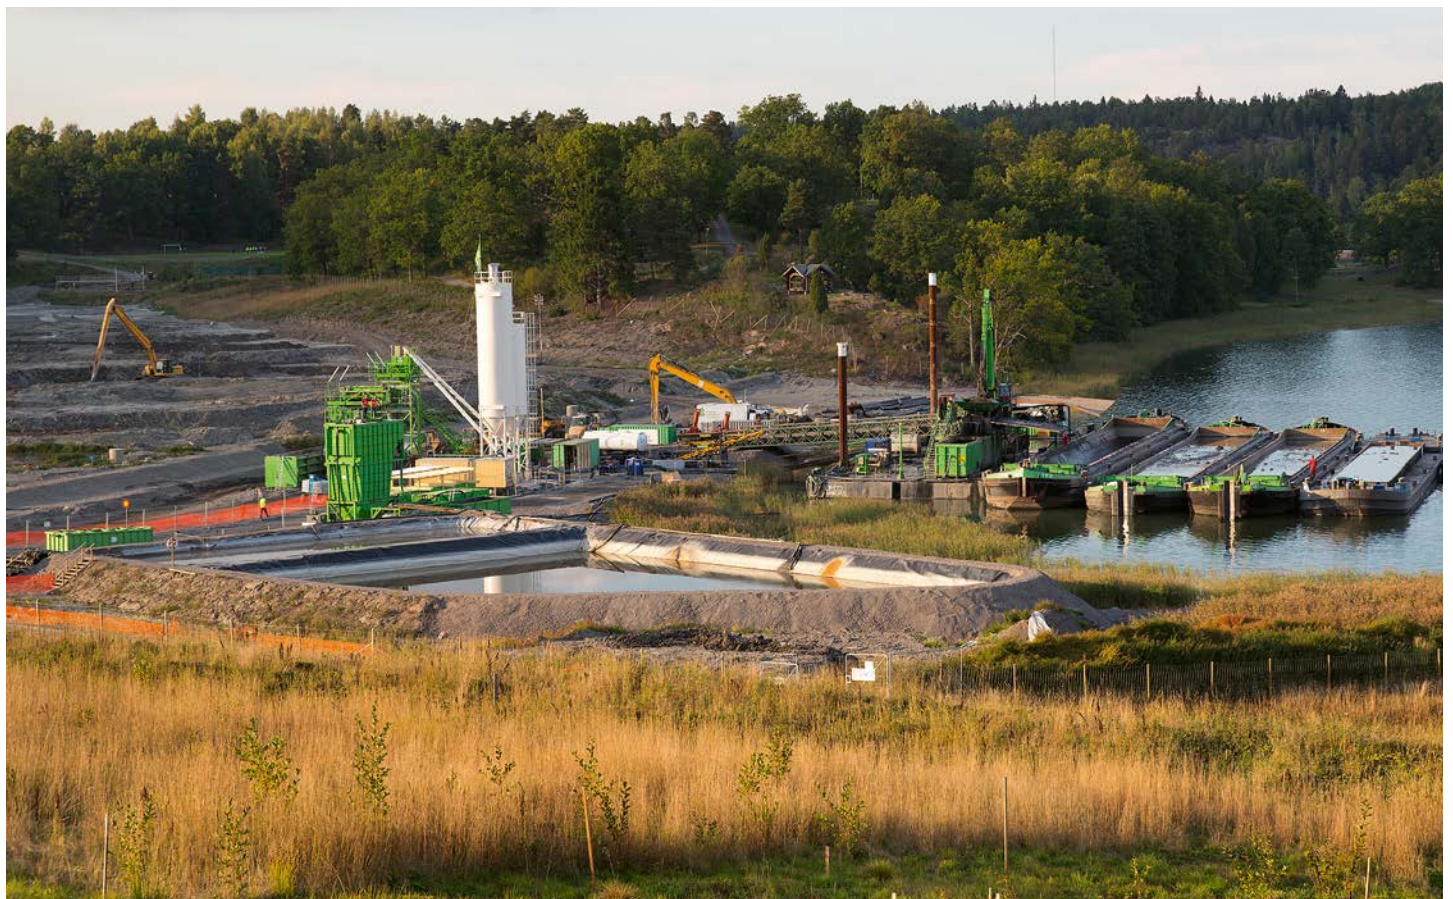
Figure 8. From right to left: Barges are unloaded; the mixing plant; and the stabilised sediments are spread into the backfilling area. At the front of the image, the water buffers from supernatant and run-off water can be seen.

Immediately after mixing, the sediments were collected in dump trucks and transported onto the Grännäs area where they were spread open by long reach excavators (Figure 8).

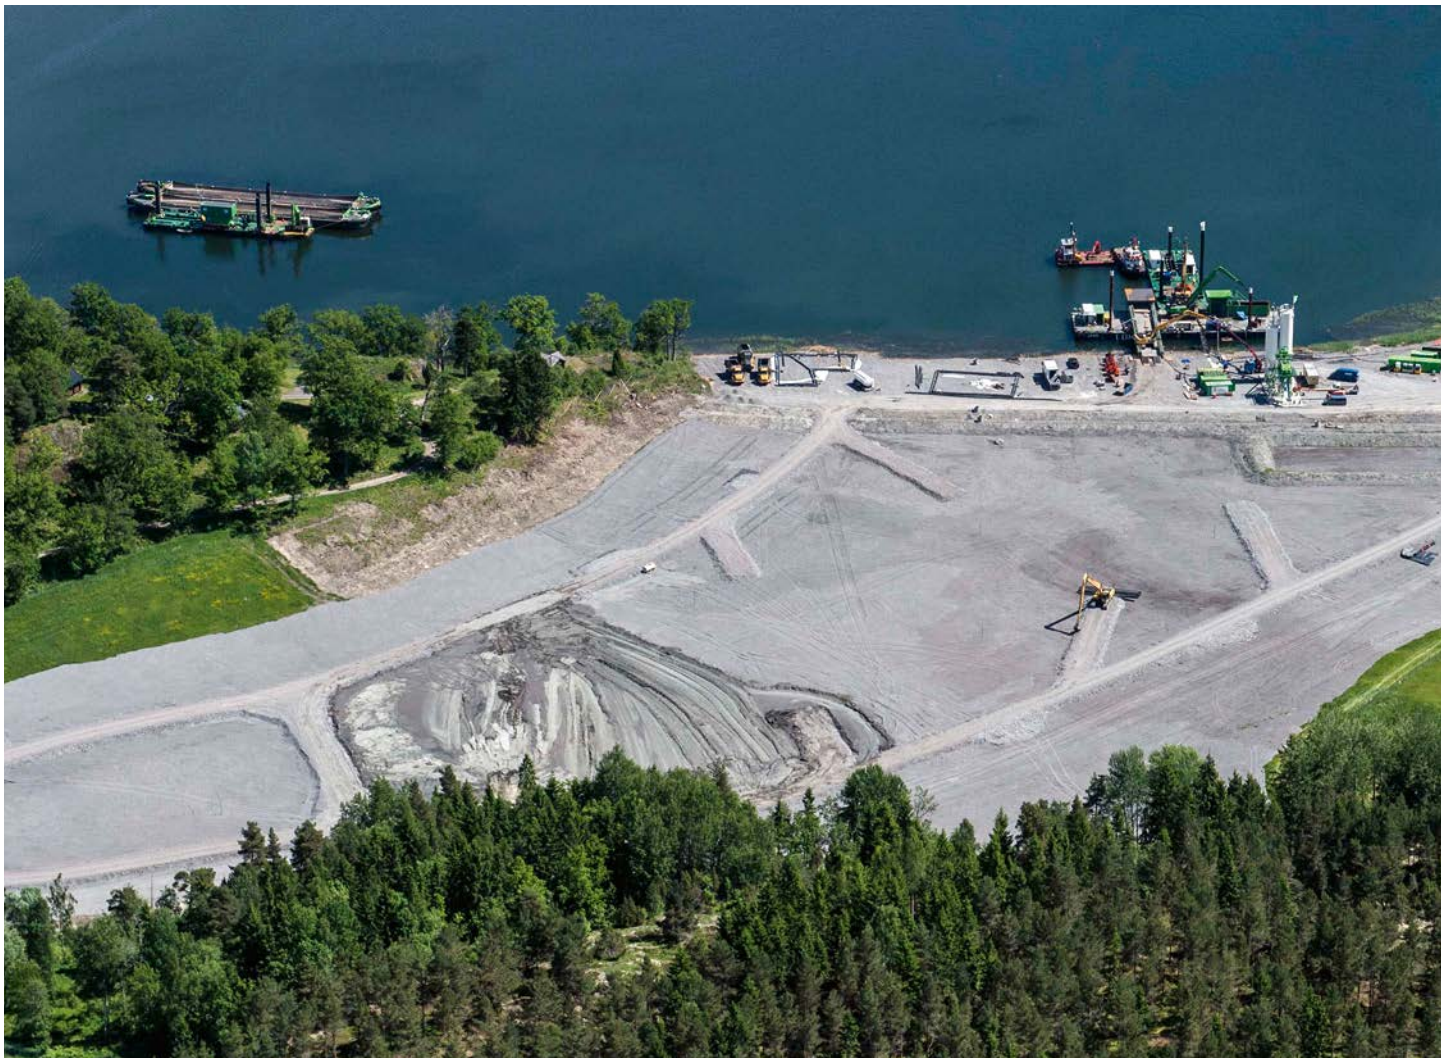
Figure 9. An aerial view of the Grännäs backfill area near completion.

A daily high production of about 2000m³ in-situ sediments was achieved. It allowed the contractor to finish the dredging and sediment treatment in less than six months. The backfilled Grännäs area had a surface of about 75,000m². The final profiling and covering with a synthetic geomembrane, bentonite mats and moraine materials, was carried out in spring 2014 (Figure 9).
