CREATING MANGROVE HABITAT FOR SHORELINE PROTECTION

WORKING WITH NATURE IN
THE ARABIAN GULF

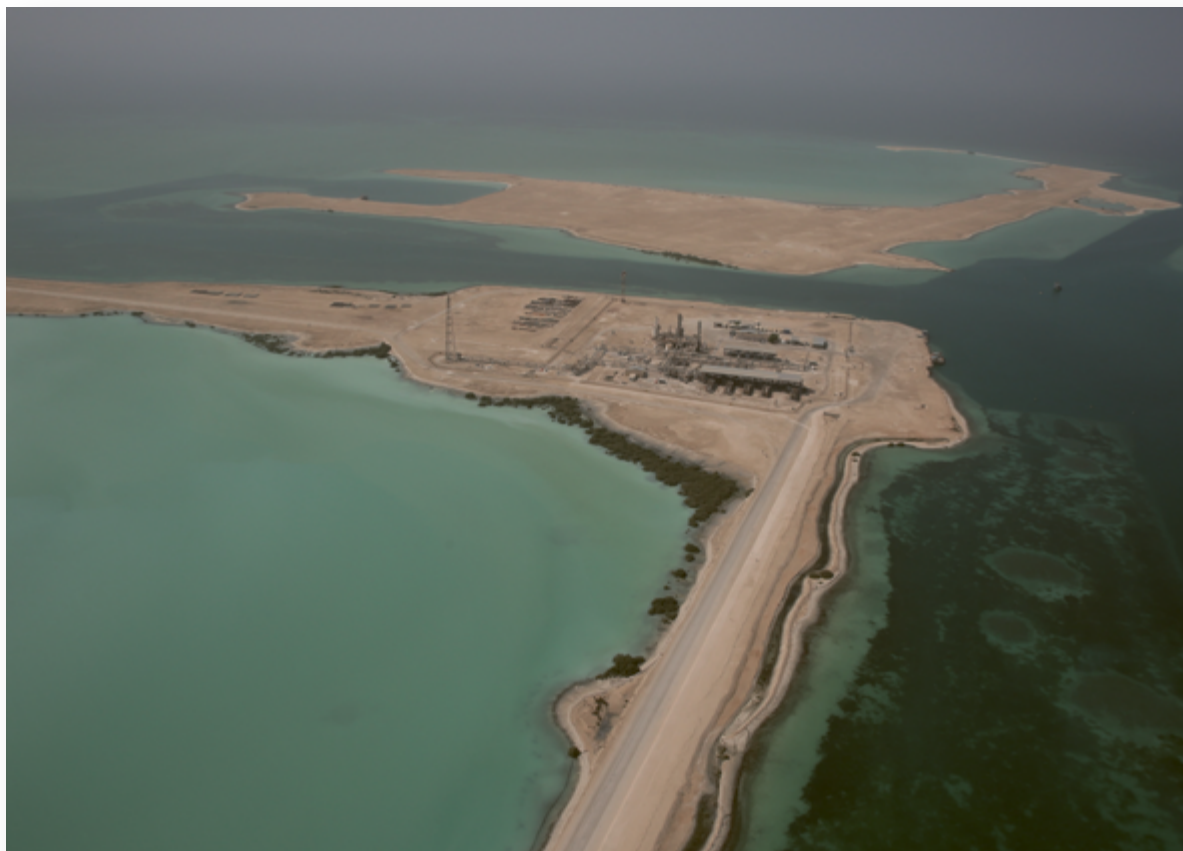
FIGURE 2

Aerial view of the northern section of the Mubarraz causeway.

Approximately 10 Mm³ of this dredged material was used for the construction of a 17-kilometre-long causeway that protects several oil pipelines and power cables, and serves as a road connection between the oil production areas and the main island. The causeway is 50–150 m wide and has a ‘height’ of 5.1 m above the adjacent seabed or approximately 3.3 m above mean sea level (MSL), assuming average water depth near the causeway to be in the order of 2.8 m, and MSL being 1.2 m above Chart Datum. The remaining ~2 Mm³ of dredged material was used for land

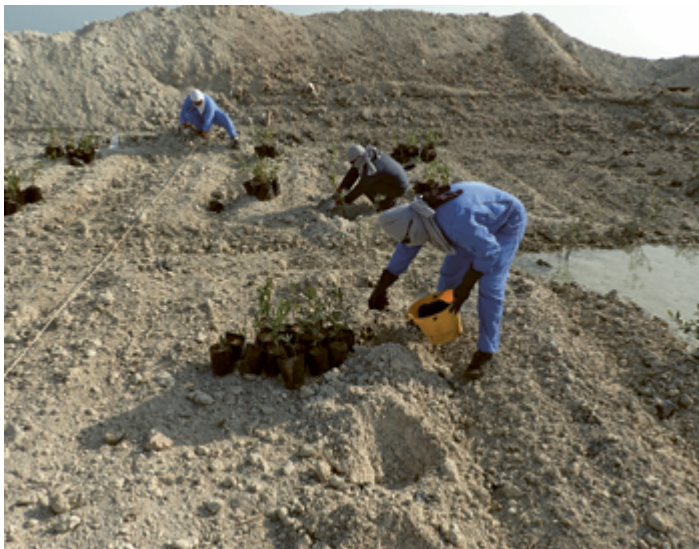
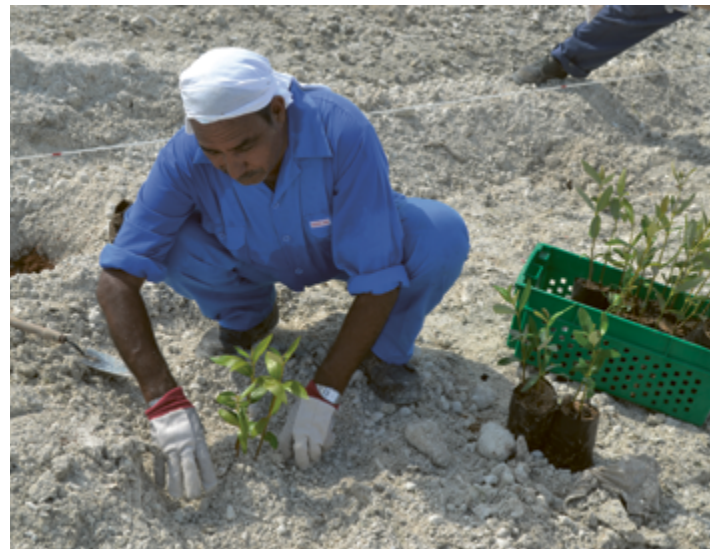
FIGURE 4
Planting mangrove seedlings inside a tidal channel.

protected from wave action and seagrass wrack accumulation. Compacted soil in the channels was loosened with rakes or spades to facilitate plant root penetration and soil aeration. Soil quality was further improved by the addition of peat moss prior to planting. Since 2006, the channels have been planted annually by staff from the oil company. Tens of thousands of mangrove seedlings

have been planted at 1 m spacing, covering different areas each year. By 2019, a total of ~500,000 seedlings had been planted. Plans for the coming years are to continue planting more mangroves, wherever possible, until most of the shoreline of the causeway is fringed on both sides by a protective belt of mature mangrove vegetation.

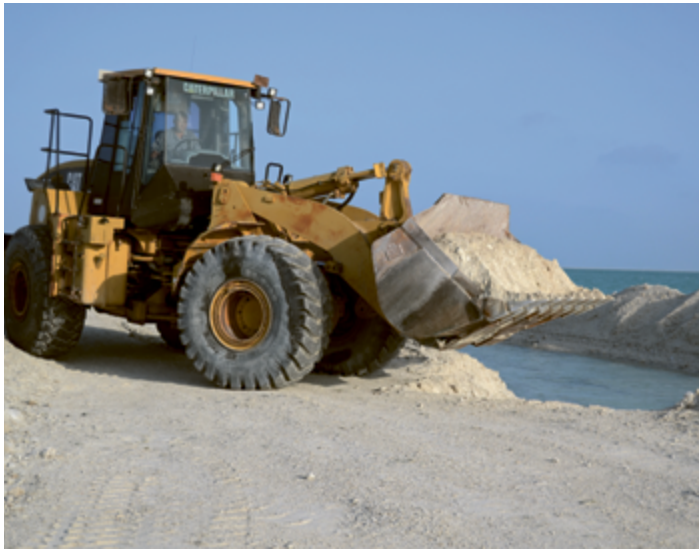
FIGURE 5
Excavation of tidal channels along causeway.

Therefore, an alternative approach had to be developed here to provide the plantings with initial protection from erosion. Artificial (tidal) channels 6–9 m wide were excavated with a backhoe along the length of the causeway, leaving a protective berm or bund of dredged material between the planting site and the open sea. The channels had passages to allow for the entry and drainage

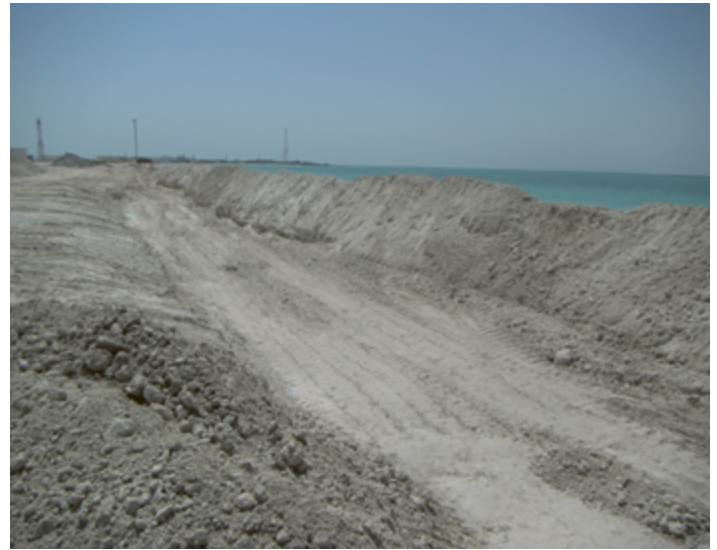
FIGURE 6
Completed tidal channel prior to planting.

Channels were dug to a depth considered suitable for mangrove growth.

of seawater with the tide and varied in length from <100 m to several kilometres. Channels were dug to a depth considered suitable for mangrove growth, generally between mean high water (MHW) and mean high water spring (MHWS) (Lewis 2005; Van Loon et al., 2016). Because these channels did not directly face the seashore, except for their intakes, the plantings were relatively

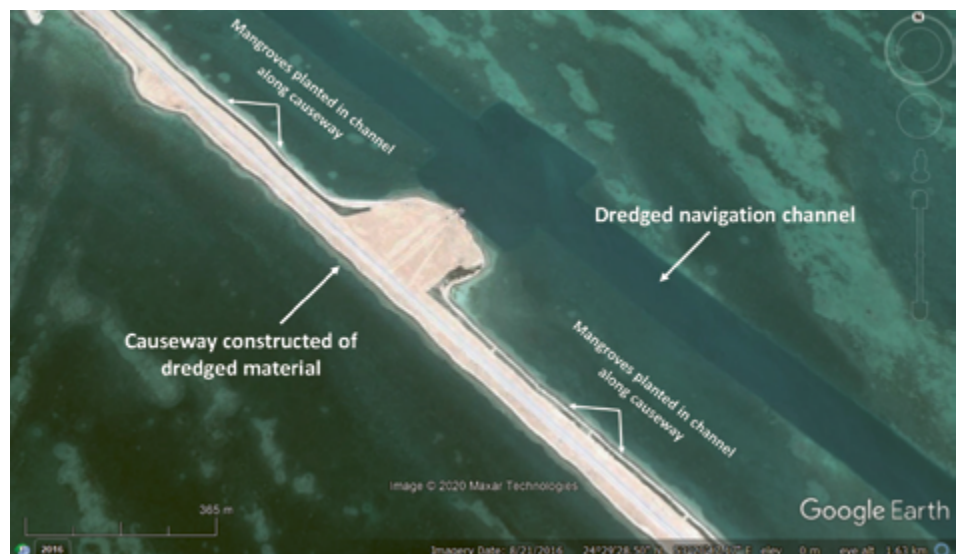
FIGURE 7
Aerial view of causeway, tidal channels and navigation channel.
Map data: Google, image © 2020 Maxar Technologies.

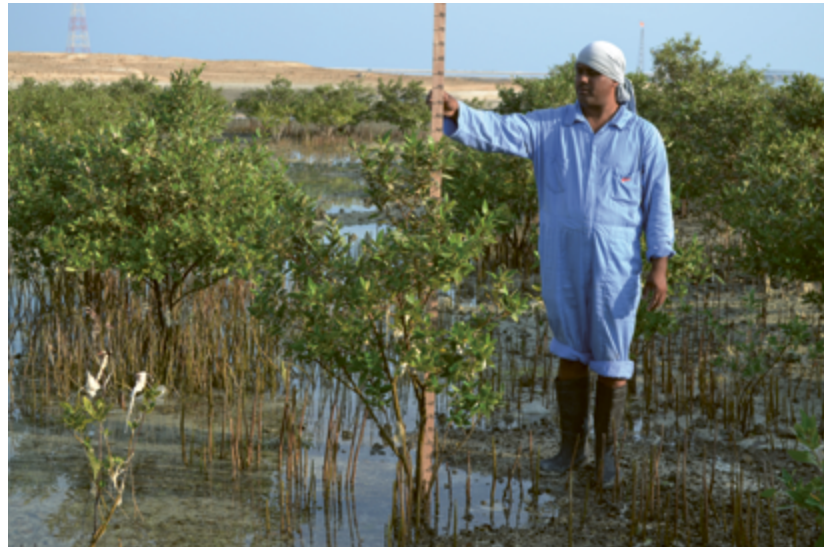
FIGURE 8

Monitoring survival and growth of planted mangroves.

A recent assessment of the overall success of the mangrove planting program at Mubarraz revealed survival rates of planted mangroves (from seedling to mature trees) to be in the order of 26% (averaged over all years), with well-established mangrove vegetation (totalling some 140,000 trees and saplings) now lining approximately 7 km of shoreline, covering 16.5 hectares (Erftemeijer et al., 2020). Successfully planted stands of mangroves were characterised by high tree density (mean: 8838 trees ha⁻¹), stunted tree height (mean: 3 m), narrow stem diameter (mean: 5 cm), moderate basal area (5–37 m² ha⁻¹), mean pneumatophore density of 589 m⁻², and healthy recruitment (>14,000 natural seedlings ha⁻¹) (Erftemeijer et al., 2020). The overall survival of 26% (or 32% if recently planted seedlings are included) of all planted seedlings at Mubarraz is comparable to natural survival rates for mangrove seedlings in the field, as reported in the general literature (see Erftemeijer et al., 2020).

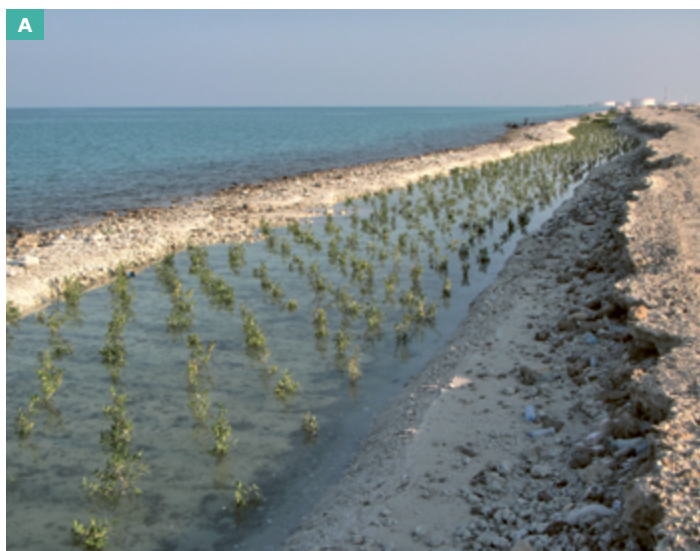
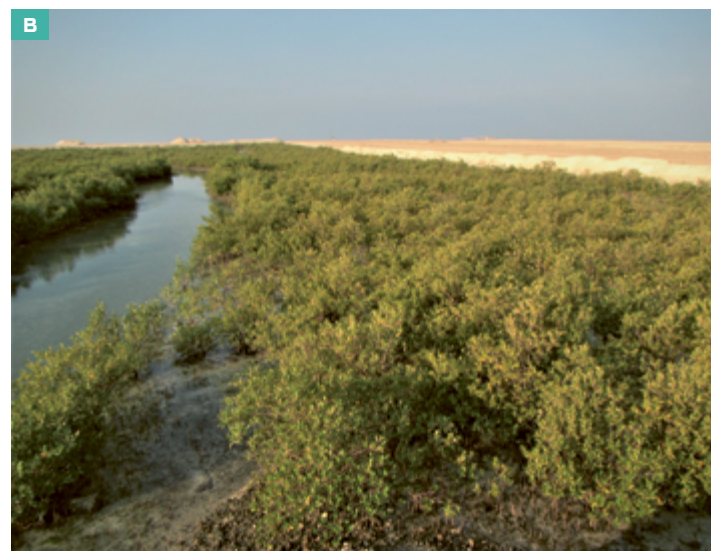
FIGURE 9

Impressions of various recent (A) and older (B) mangrove plantings in tidal channels behind protective berms along the causeway.

The protective berms of dredged material along the mangrove channels occasionally required maintenance to repair sections affected by storm damage. Following planting, the young mangrove vegetation will not offer much shoreline protection initially, but as the mangrove stands develop and expand over the years, they can substantially reduce wave height and energy, and contribute to protection from erosion, depending on tree density, stem diameter and the density of their pneumatophores. It is expected that over the coming decade, these mangroves will have grown and established themselves sufficiently enough to withstand significant wave energy and protect these shorelines from erosion after the protective berms of dredged

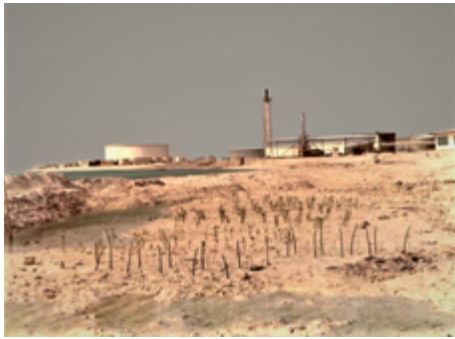
FIGURE 10
Mangrove planting on Mubarraz Island photographed in 1984.

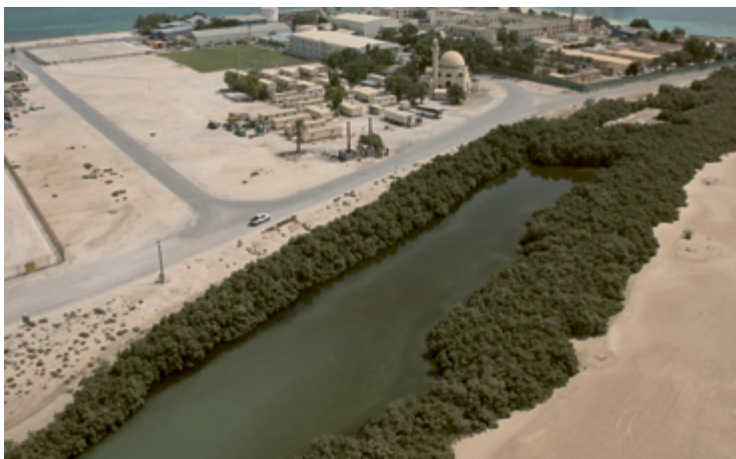
FIGURE 12
Aerial view of mangroves along a channel at Mubarraz Island (protecting infrastructure).

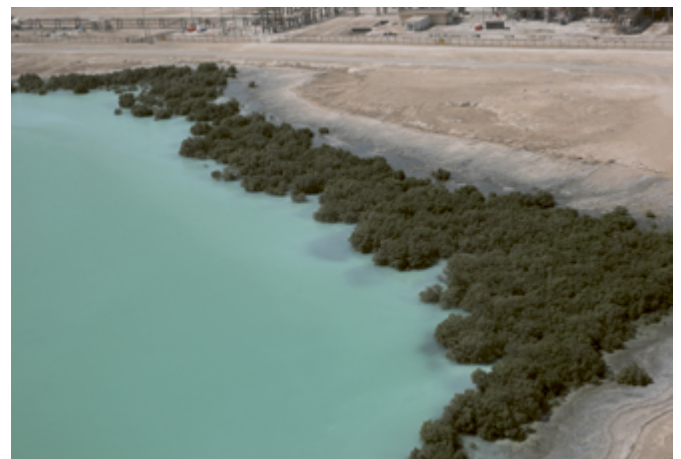
FIGURE 13
Mangroves adjacent to oil infrastructure at West Mubarraz.

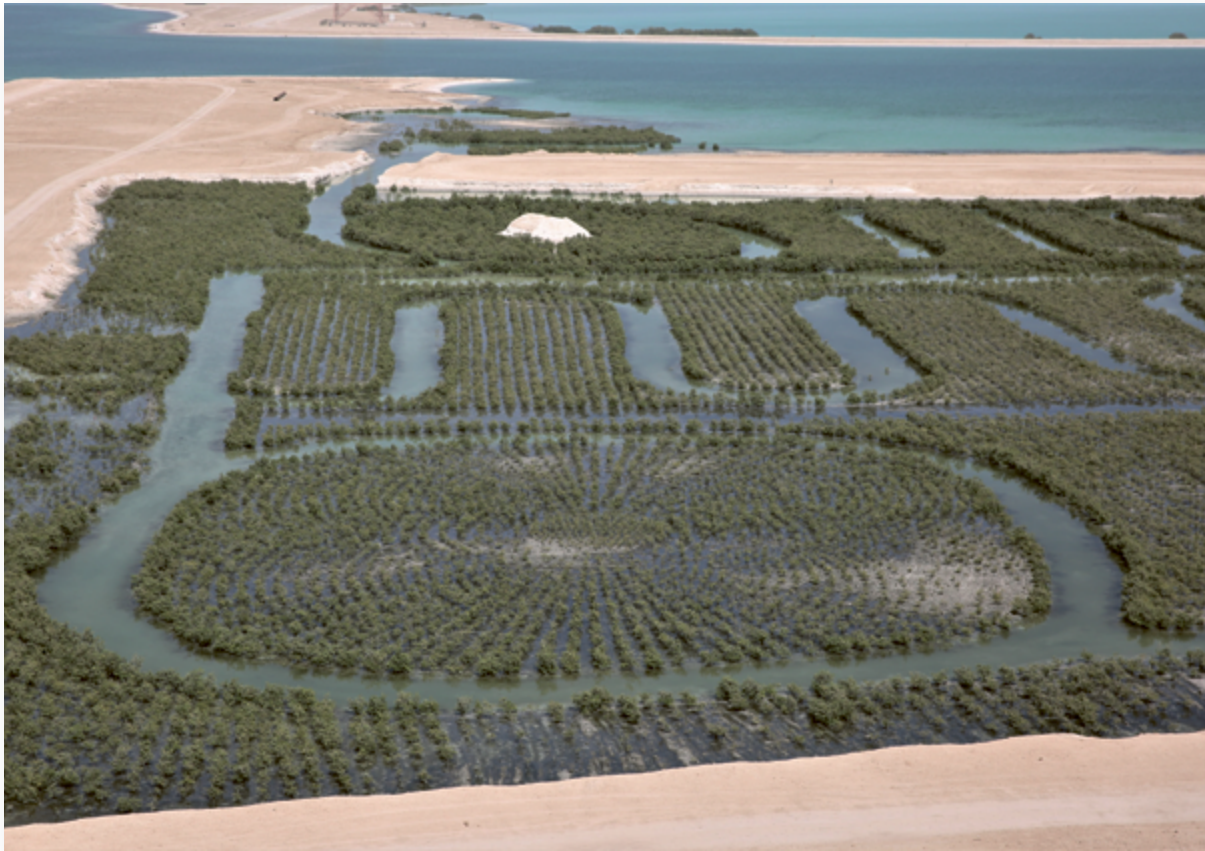
FIGURE 14
 'Mangrove pool', a more recent 6.7 hectare mangrove planting programme on West Mubarraz.
